US Army Corps
of Engineers
Waterways Experiment
Station

Contract Report HL-93-2
September 1993

Guidelines for the Use of Stream Reconnaissance Record Sheets in the Field

by *Colin R. Thorne*
University of Nottingham

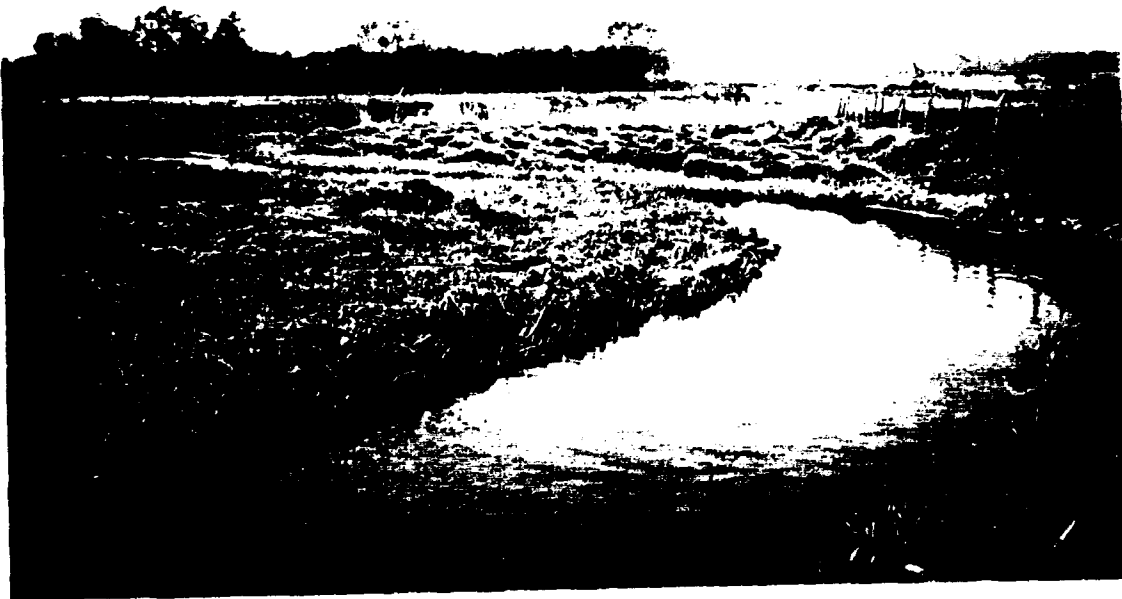
Figure 3. a) Upland river with a narrow flood plain and frequent coupling of channel and active erosion of valley side b) Lowland river with broad flood plain and uncoupled channel and hillslope processes.

Valley Floor Type and *Valley Floor Data* note the presence or absence of a flat valley floor and its width in relation to the width of the channel. Rivers with fragmentary or narrow valley floors are closely coupled to hillslope run-off and erosion processes operating on the valley sides and are also liable to destabilization by valley side slope failures and sediment inputs. This is not true of rivers with broad flood plains. (Fig. 3 a and b).

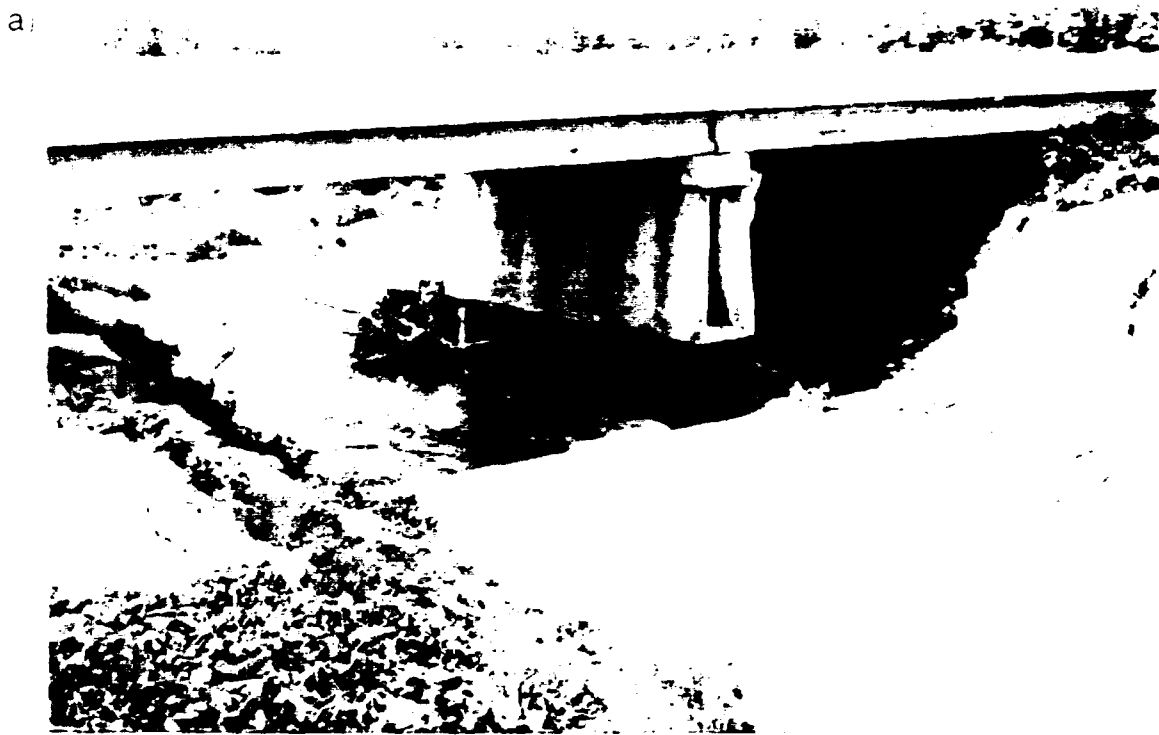
Figure 6 Examples of: a) an incised river b) an aggraded river

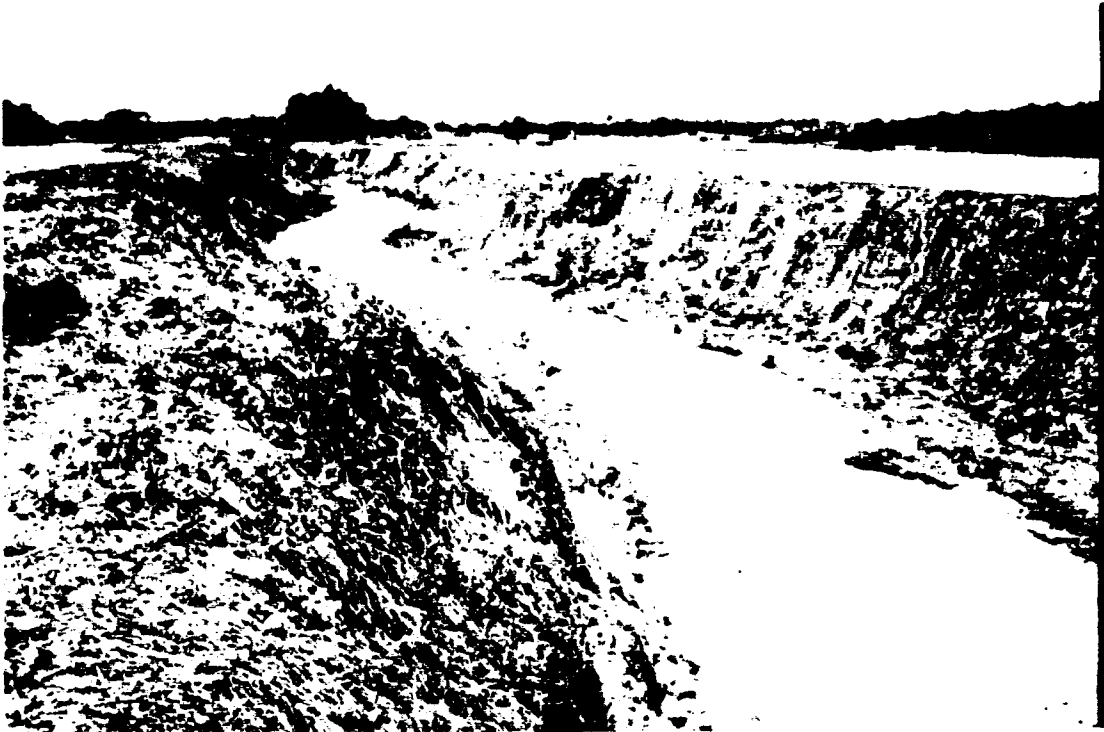
Figure 10. Examples of: a) a shifting river in dynamic equilibrium, b) an over-wide channel and c) a channel which is too narrow

Present Status defines whether or not the channel width is adjusted to the present flow regime. Adjusted channels have stable widths over time, although they may still be laterally active if they erode one bank and deposit sediment at the other (Fig. 10a). This is termed 'dynamic equilibrium'. Over-wide rivers are broad and shallow with shifting bars. They have stable banks and accumulated sediment shelves at the toes of both banks, producing a composite, "two-stage channel" type of cross-sectional shape (Fig. 10b). Narrow rivers have low aspect ratios, active erosion of both banks, no sediment stored at either bank toe and more trapezoidal cross-sections (Fig. 10c).

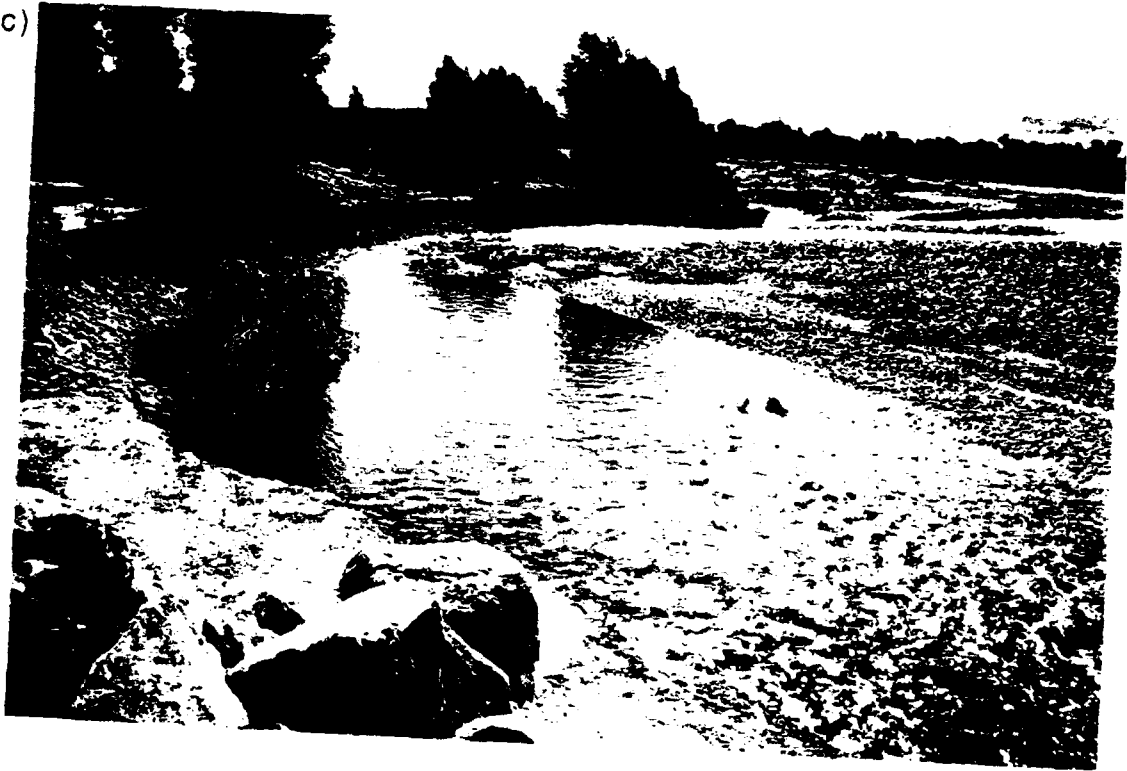
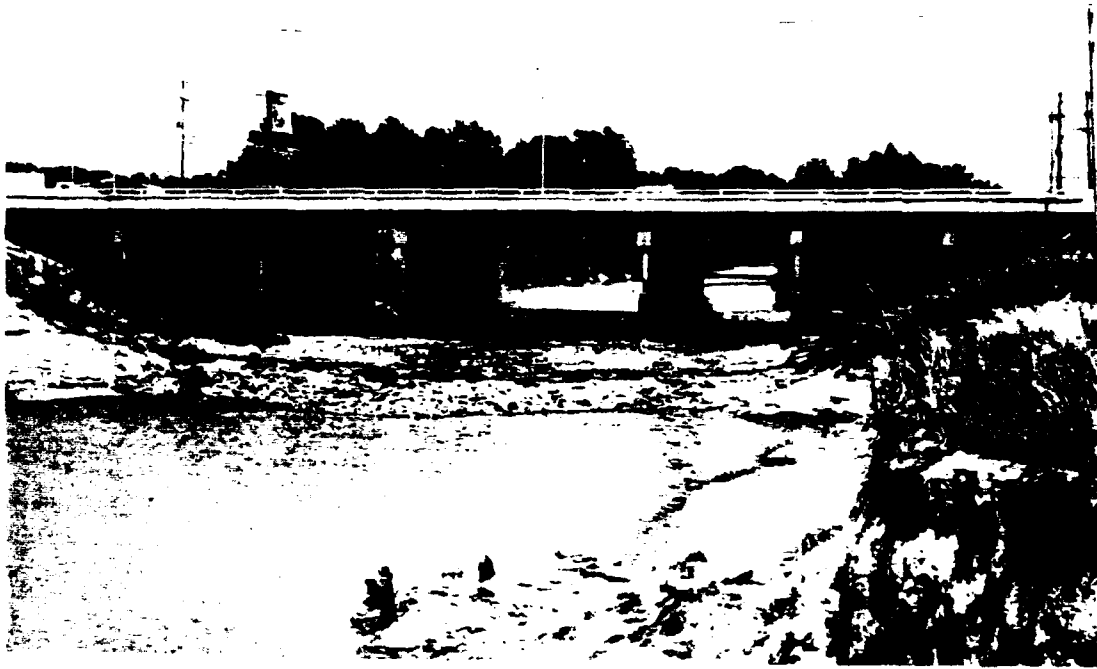
Figure 12. Types of bed control in rivers. a) Bedrock; b) Boulders; c) Gravel armour; d) Cohesive materials; e) Bridge protection; f) Grade control structure

Control Types defines the nature of the bed controls (Fig. 12). Natural examples are bed rock outcrops, coarse sediments which form an immobile armor layer, and fine sediments which are strongly cohesive. Where natural controls like these are absent, weirs or cut-off walls may be constructed to prevent bed degradation. Such *grade control structures* are vital where severe degradation is occurring and natural controls are either absent or unreliable. Foundations and protection constructed at bridges and culvert crossings may also act as bed controls.

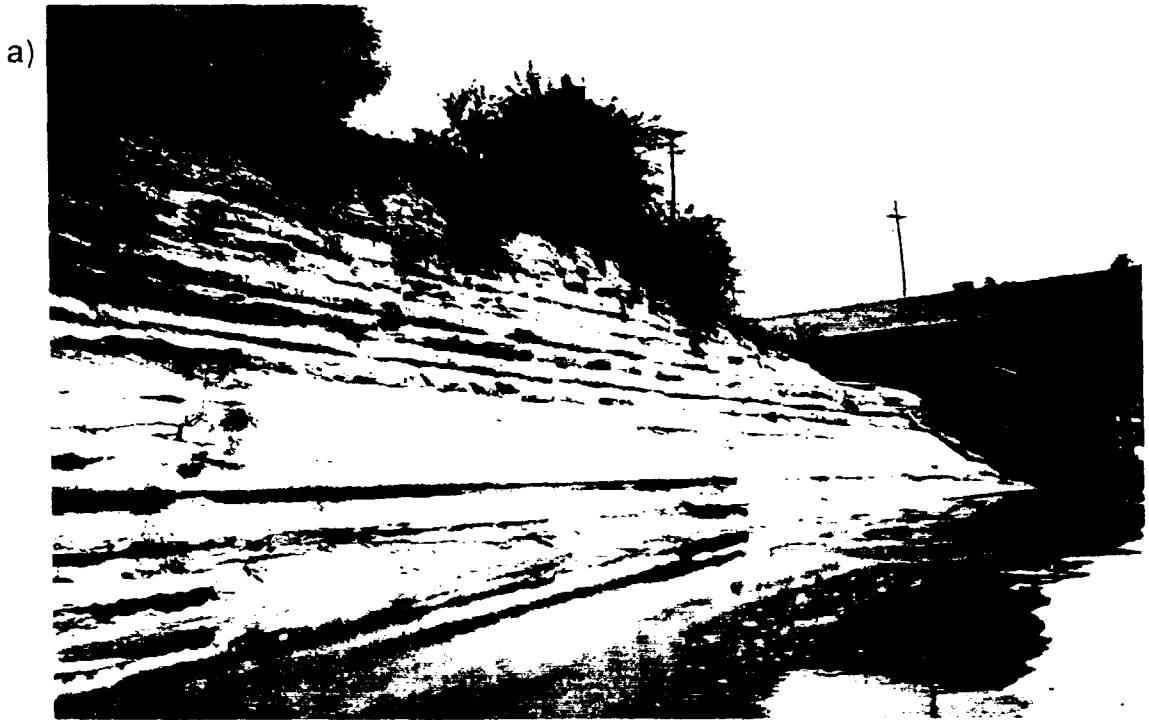
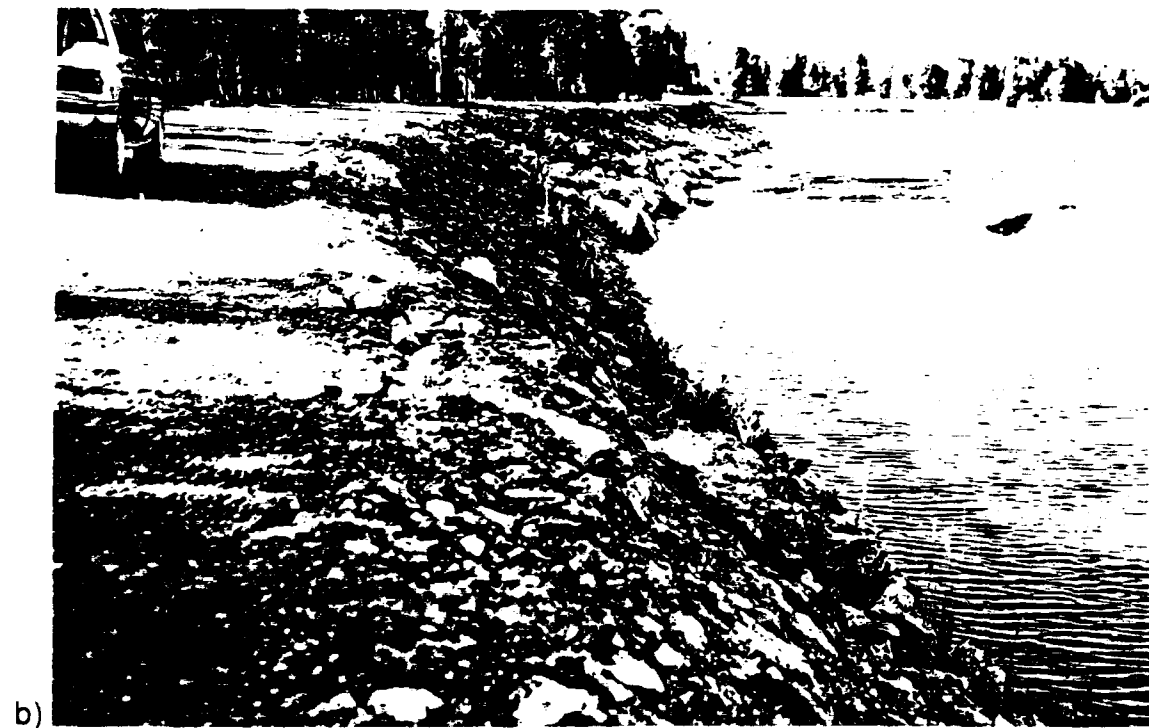
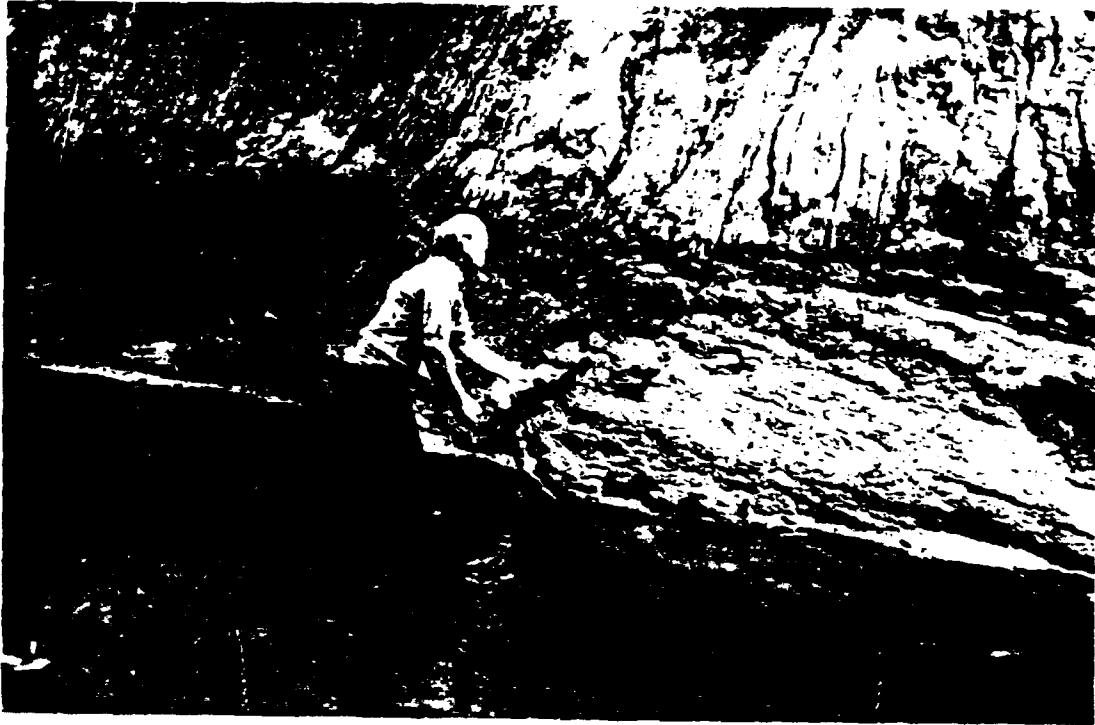
Figure 13. Types of width control in rivers. a) Bedrock; b) Revetment; c) Cohesive materials d) Bridge abutments. For boulders, gravel armour and dykes/groynes see Figs. 12b, 12c and 19d, respectively

Control Types define the nature of the width controls (Fig. 13). Natural examples are bed rock outcrops, coarse sediments which form an immobile armour on the bank, and fine sediments which are strongly cohesive. Controls due to fine sediments are often associated with clay plugs and back swamp deposits in the flood plain left by earlier depositional activity. Where natural controls like these are inadequate, dyke fields and/or revetments may be used to control river width and bank line movement. Such *training structures* are a vital part of bank protection schemes in systems where width is unstable and natural controls are either absent or unreliable.

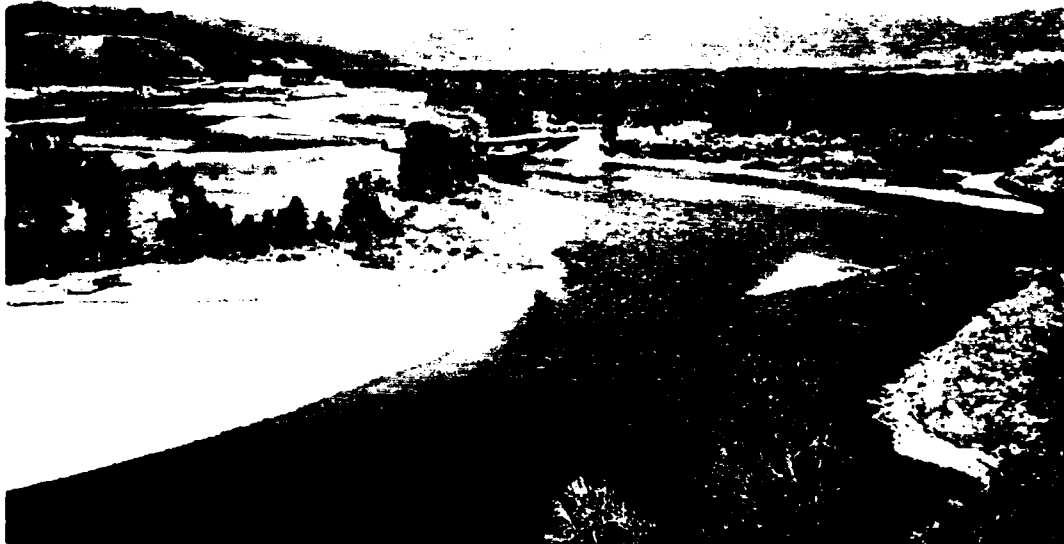
Figure 17. Example site photographs: Snake River near Jackson Hole, Wyoming. a) P1, view upstream over site, b) P2, view of under-cutting and sliding of valley side

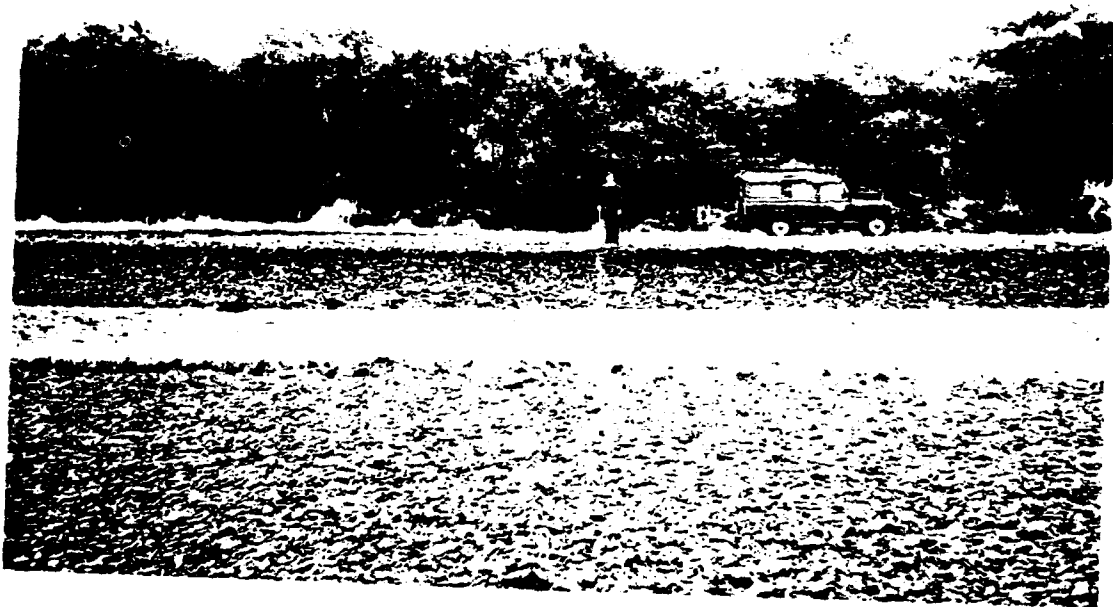
Figure 18. Bank Types: a) Noncohesive; b) Cohesive; c) Composite;
and d) Layered

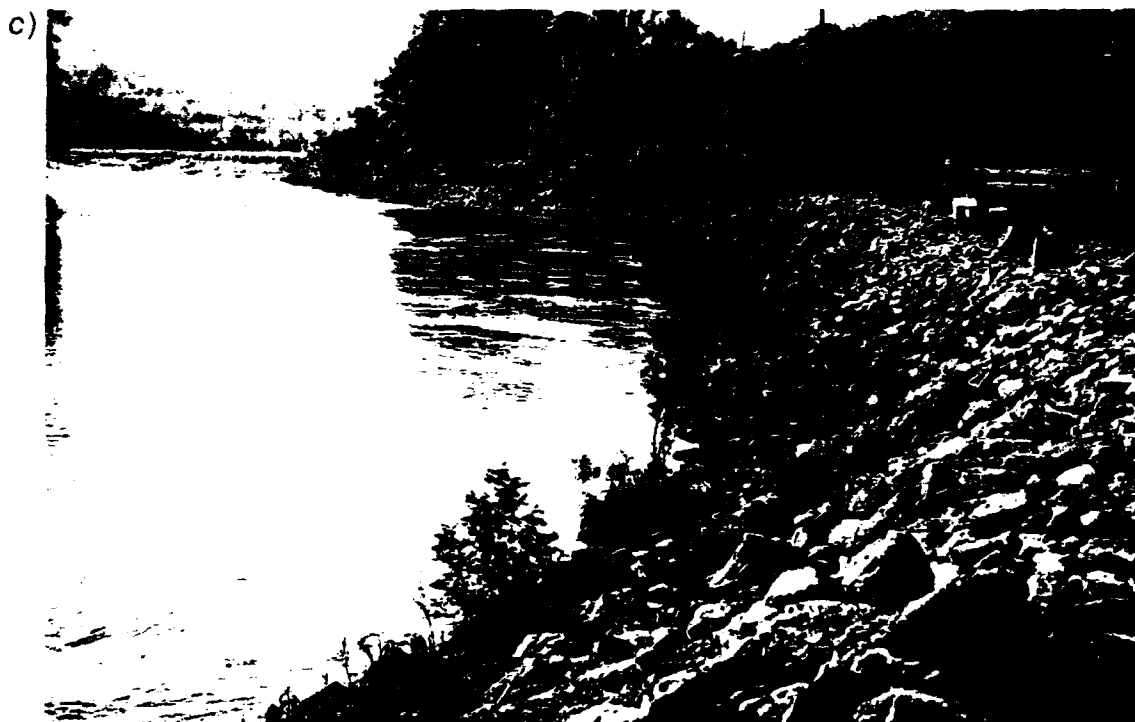
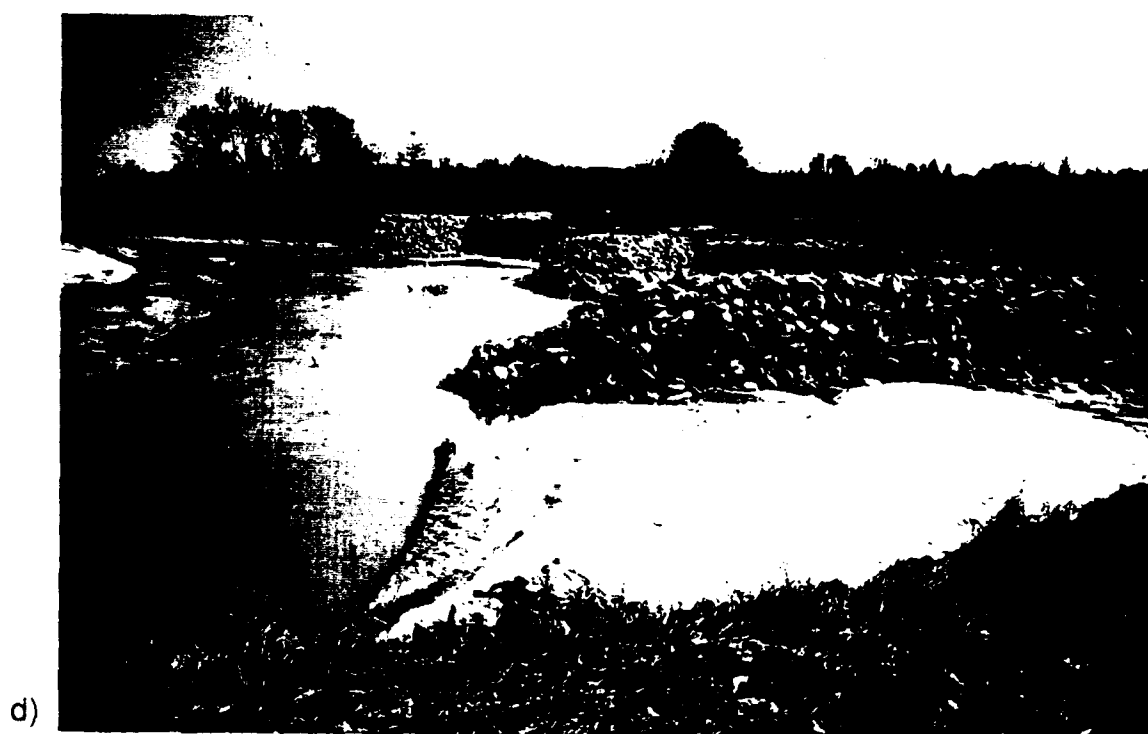
Figure 19. Types of bank protection: a) Hard points; b) Toe protection; c) revetment; and d) dyke fields

Protection Status establishes whether the bank is unprotected or has been subject to engineering stabilization (Fig. 19). Where a bank has been protected the condition and effectiveness of the structure should be described in the *Notes and Comments* space.

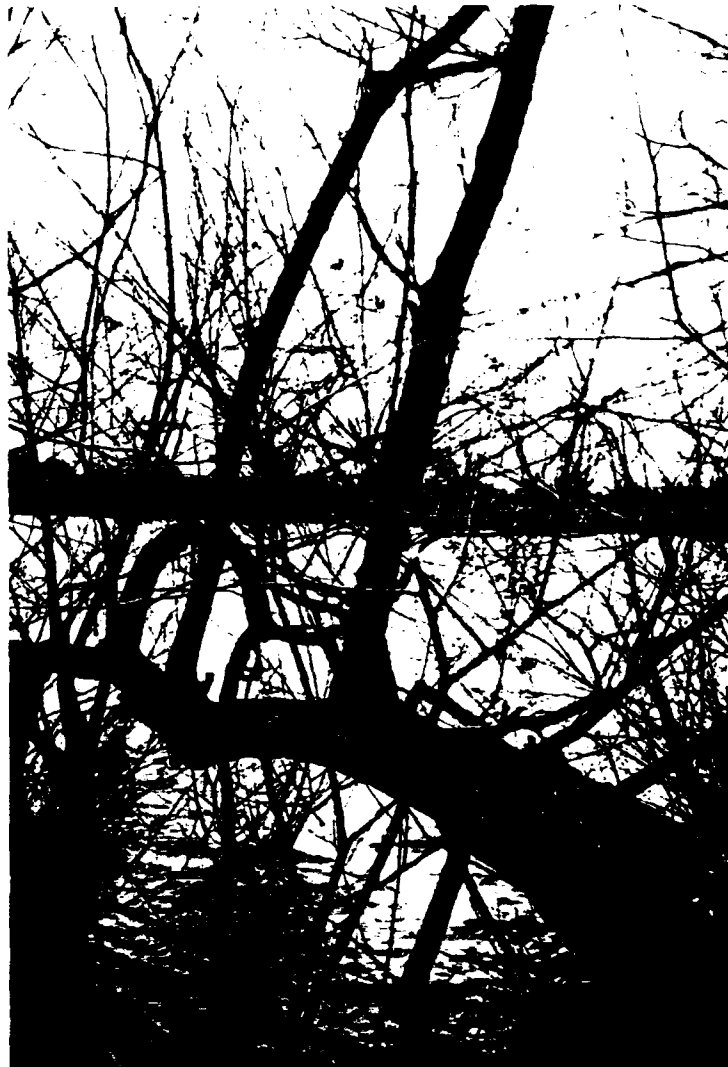
Figure 23. New stems shooting upwards from a downed tree. Counting rings in the stems gauges the time elapsed since failure

Fallen trees which are not dead produce new stems which grow vertically from the downed trunk (Fig. 23). Breaking off such a stem and counting the annual rings is a good way to gauge the time elapsed since the failure.

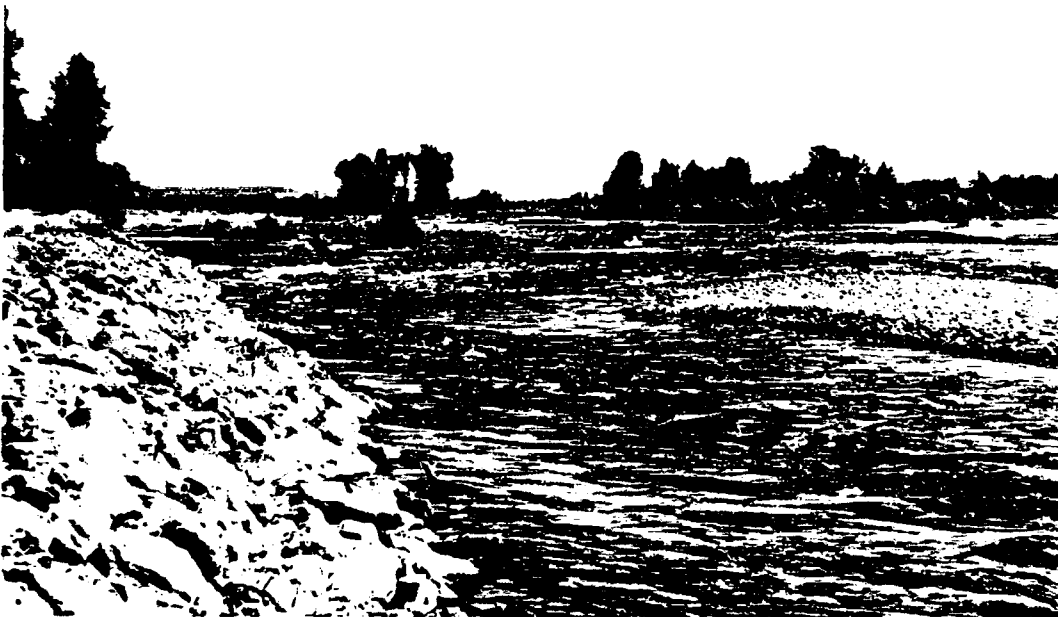
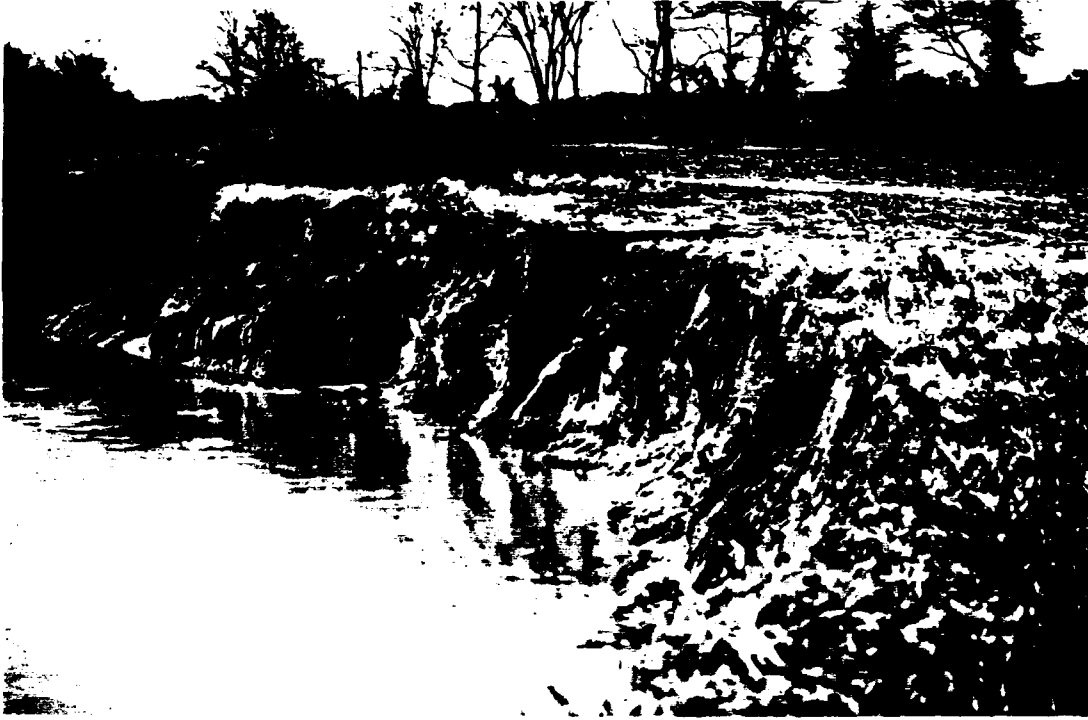
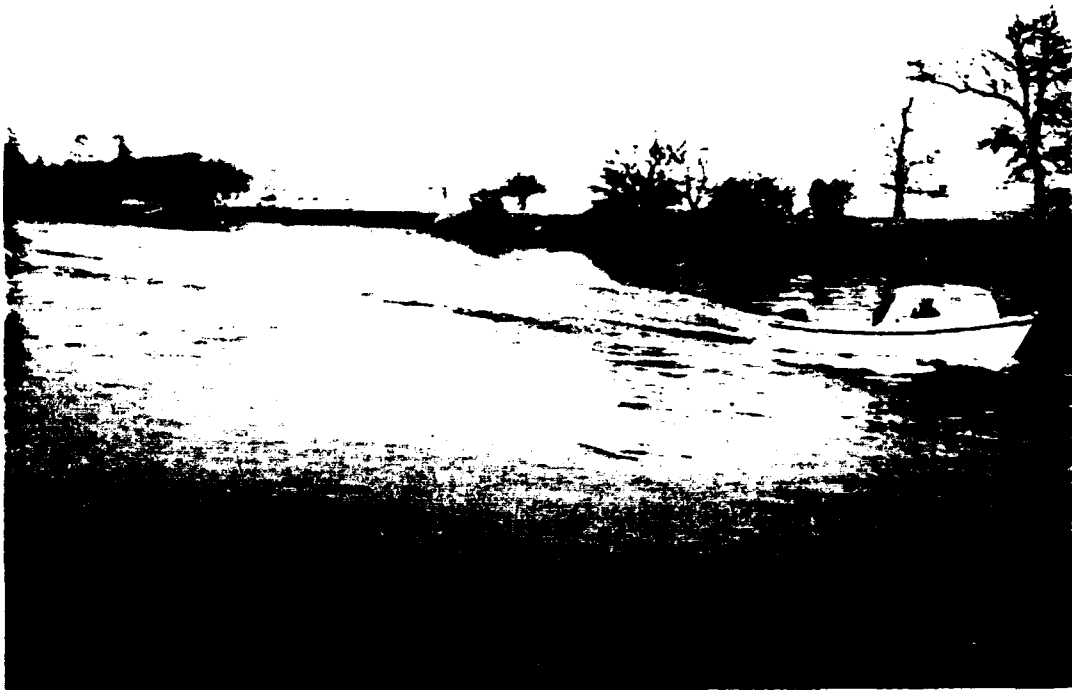
Figure 26. Bank erosion processes observed in the field.

- a) Parallel flow; b) impinging flow; c) piping;
- d) freeze/thaw; e) sheet erosion+rilling/gullyying;
- f) wind waves; g) vessel forces and resulting erosion

Parallel Flow erosion is the detachment and removal of intact grains or aggregates of grains from the bank face by flow along the bank. Evidence includes: observation of high flow velocities close to the bank; near-bank scouring of the bed; under-cutting of the toe/lower bank relative to the bank top; a fresh, ragged appearance to the bank face; absence of surficial bank vegetation.

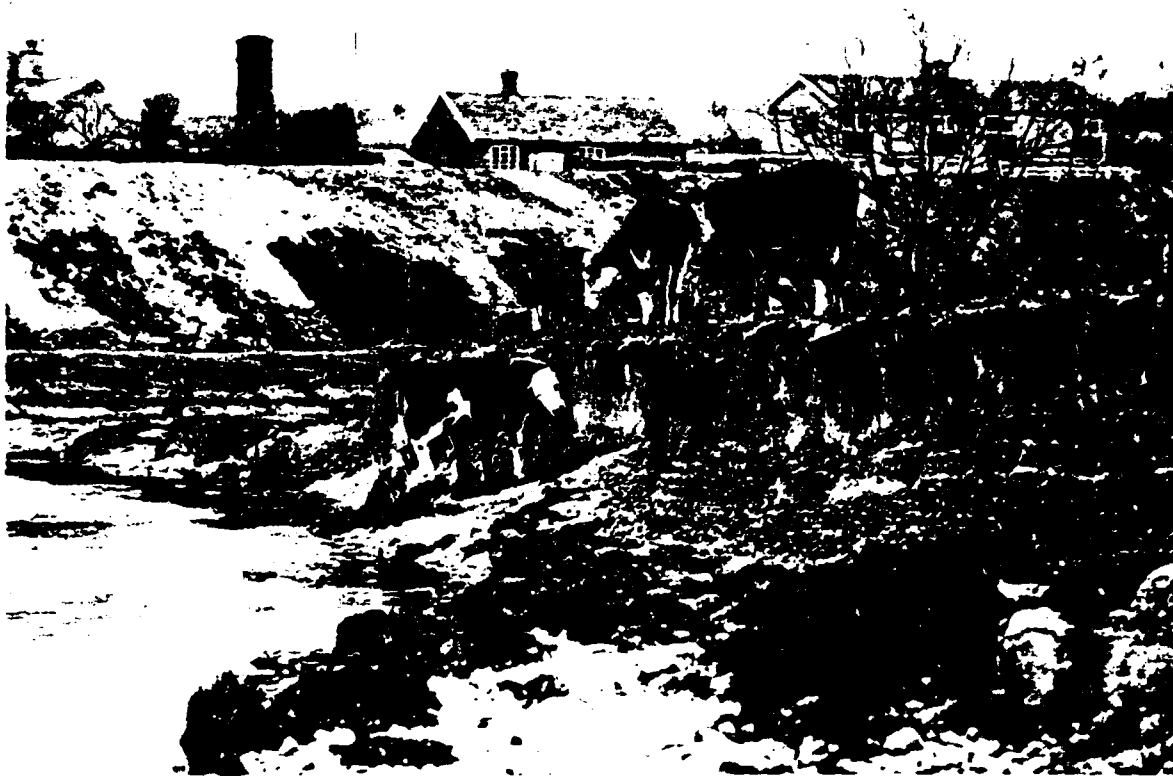
Figure 27. Examples of different modes of geotechnical stream bank failure. a) Soil fall; b) rotational slip; c) slab failure; d) cantilever failure; e) pop-out failure; f) piping; g) dry granular flow; h) wet earth flow; i) example 'other' failure mode - cattle trampling

Failure Mode attempts to identify the type of failures resulting from bank instability (Fig. 27). This is not an easy task and often requires some training. It is assumed here that the individuals undertaking the survey are somewhat familiar with slope failure mechanics and bank collapse.

Interpretation rests on recognition of the geometry of the bank which results from different mechanisms. Some guidance is given here.

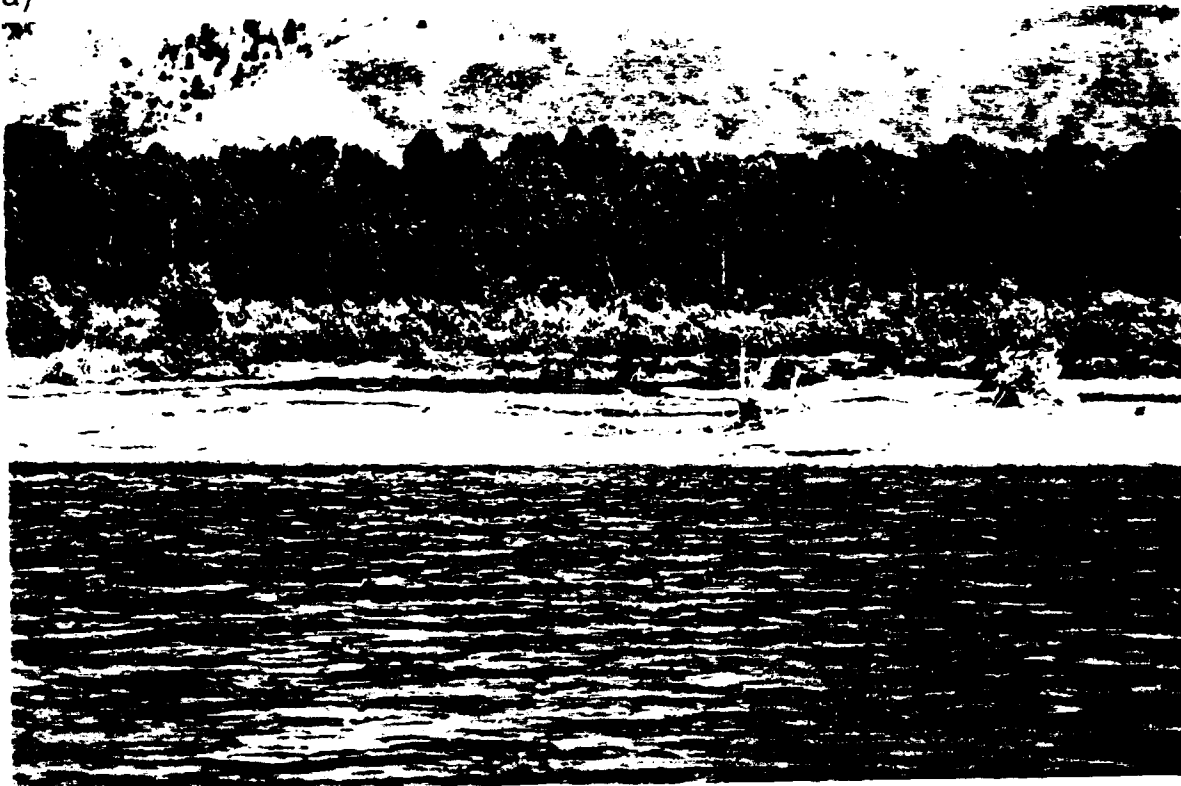
Figure 29. Bank Shelf vegetation of different ages. a) Immature vegetation on a shelf in front of mature flood plain forest; b) mature vegetation on bench on left bank; c) old trees on shelves on both banks

Age can be a useful guide to the recent history of undercutting or sediment accumulation (Fig 29). Old and mature vegetation clearly can only develop on a stable bank shelf. A lack of vegetation or a predominance of young, immature plants hints at a recently deposited shelf that may be a temporary feature, being destroyed at high flow.
